# Perry Hall (The Mahler Farm) Historic Structures Report

Draft, June 15, 2015

David B. Schneider  
Schneider Historic Preservation, LLC

Lowell Christy  
Christy/Cobb Consulting Engineers, Inc.

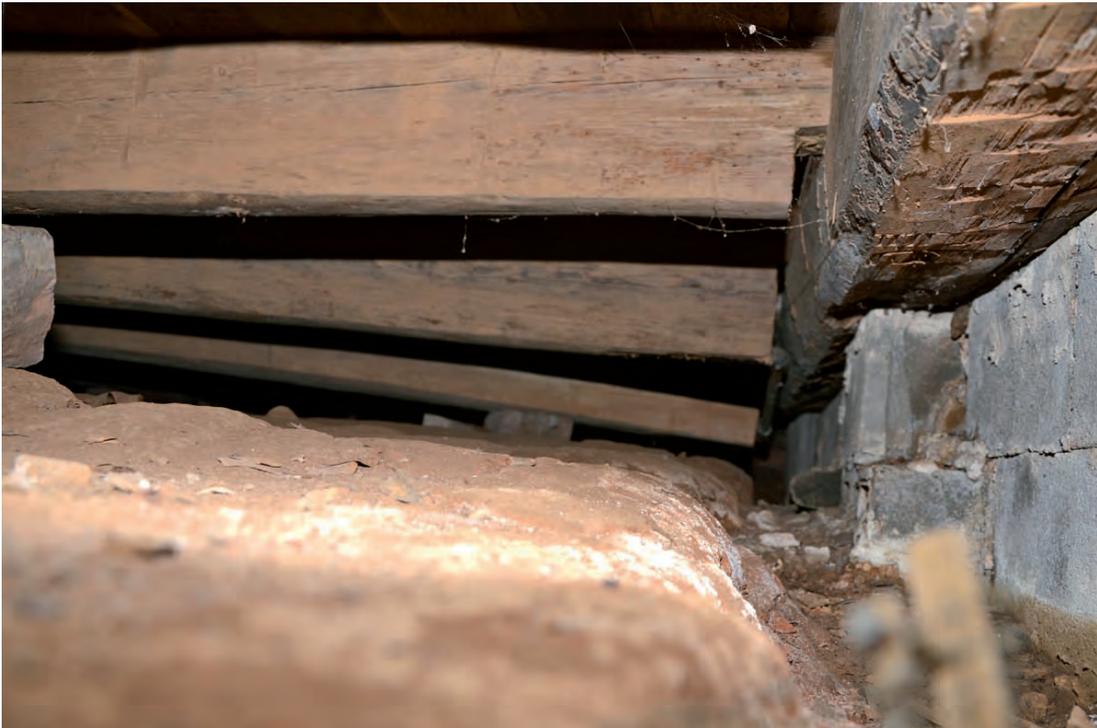
The first four of these conditions are likely interrelated: the generally undulating and springy feel of the first floor flooring and the sloping character of the second floor; the presence of settlement and deflection cracks in many areas of the house; and termite damage that was visible in the basement in the joists supporting the kitchen. Evidence of repeated patching of some of the settlement and deflection cracks suggests that the underlying structural deficiency has been an ongoing issue for many years. An examination of the attic and roof system did not indicate any appreciable moisture penetration into the building. Accordingly, the suggested cause of the settlement and deflection appears to be in the foundation and framing systems.

Access to the crawl space under the house is limited, as the floor joists and sills are typically less than 18" above grade. Without the aid of specialized viewing equipment or the opening of more access points along the foundation, it was only possible to observe a small area under the house and to obtain a few photographs. What was immediately visible along the sill at the front (south) façade of the house was that a number of floor joists that have separated in whole or part from the sill. This condition would certainly account for some of the settlement and deflection cracks that are found throughout the interior and the undulating and spongy nature of the first floor flooring. Due to the limited access, it was not possible to assess the conditions under the house beyond the one access point at the west end of the south wall. However, the presence of settlement and deflection cracks and the springy nature of the floor throughout the house indicates that similar conditions may exist along the western sill line and that there may be other issues with the floor joists themselves.

Photo 55. Detail View of Sill at South Facade. Note: Floor joists have slipped away from the sill causing floor system to sag.

Recommendation. The conditions at the foundation require more detailed examination that is beyond the scope of this project. Because the conditions within the crawlspace appear to be responsible for the ongoing settlement and deflection of the floor systems and the resulting cracking at ceiling and wall finishes, fully identifying the extent of deficiencies present, developing a plan to correct them, and making the necessary repairs is of primary

importance before any restoration work or adaptive reuse of the house can be effectively implemented. Accordingly, it is recommended that a structural engineer be engaged to provide a detailed assessment of these conditions. Such work will require, at a minimum, the use of a light scope or mechanized device that will allow observation of the entire crawlspace. It is also likely that several access points will need to be opened within the perimeter concrete masonry unit underpinning. The removal of vents and/or the creation of other openings in the underpinning will require the use of a contractor or possibly a city work crew working with the guidance of the engineer. Once this level of observation is made possible, the engineer will be able to determine if the access is sufficient or whether or not there are areas that will need to be accessed by opening access holes in the interior flooring system. The latter is specialized work that will require care not to damage flooring and/or interior finishes.

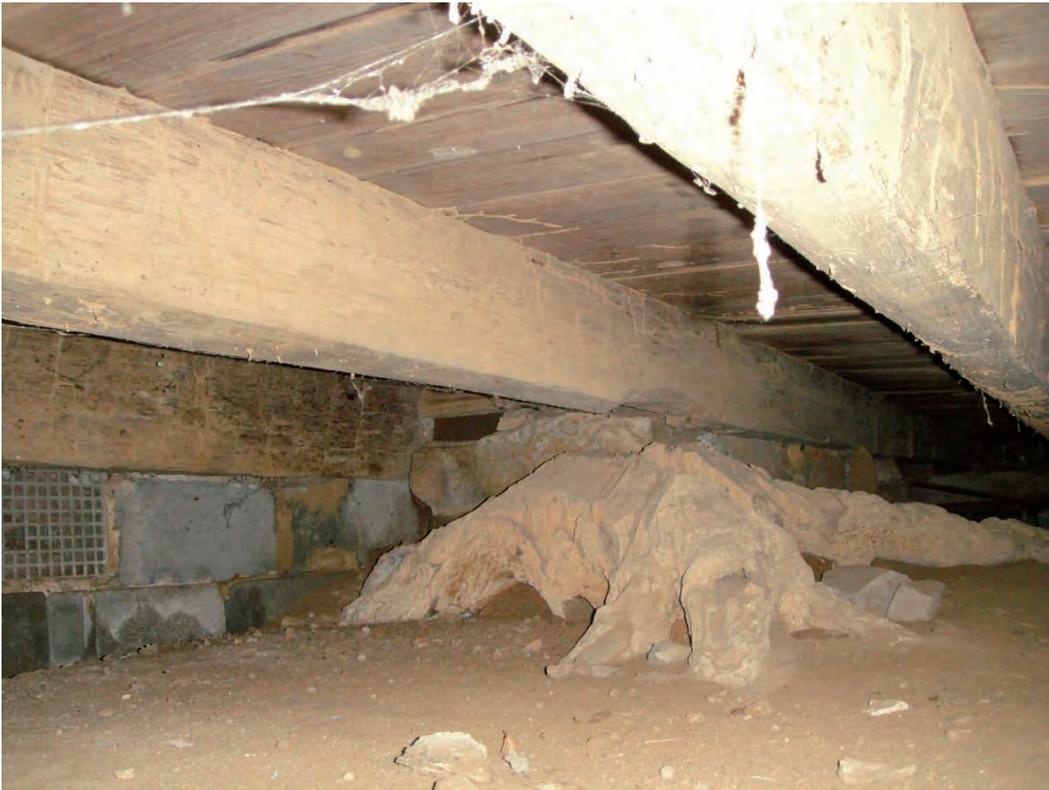
Photo 57. Detail at Crawl Space. Note: Floor joists are supported by a mix of rock outcroppings and some irregularly spaced piers.

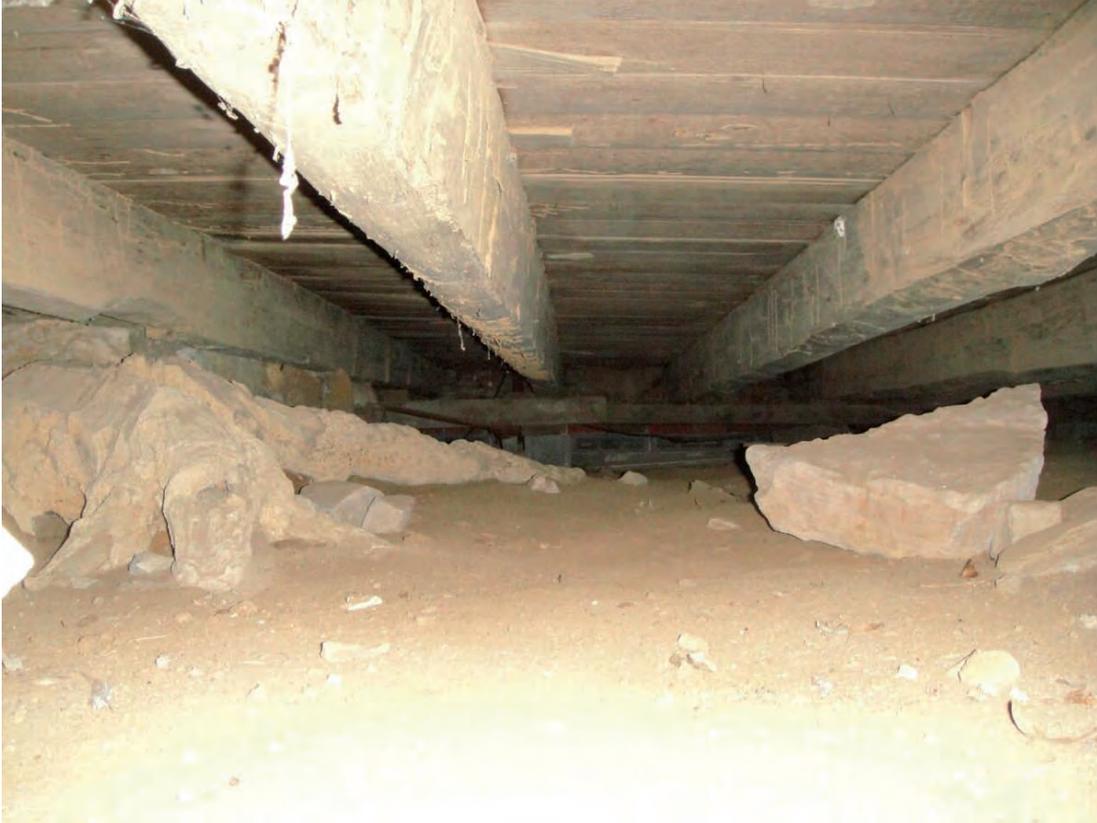
Photo 58. Detail at Crawl Space. Note: Floor joists are supported by a mix of rock outcroppings and some irregularly spaced piers.

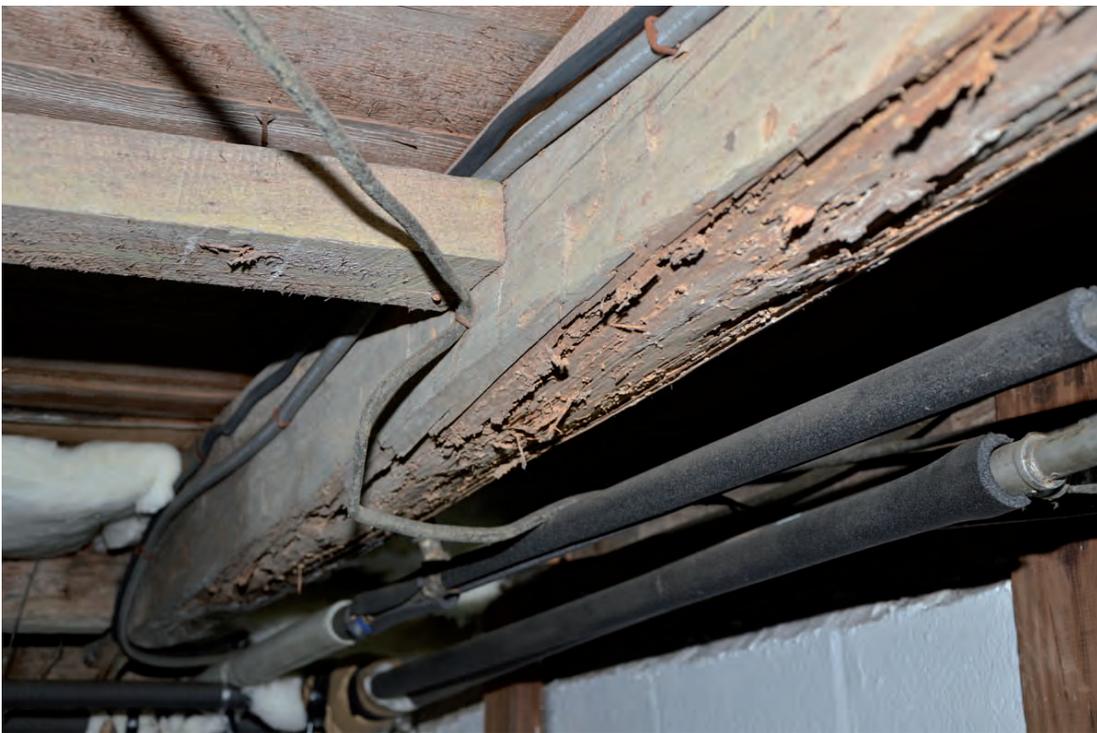
Some termite-related damage was also observed within the basement at the southwest corner of the building. Again, due to the limited access available to the crawl space, it was not possible to fully assess whether or not additional termite damage was present in other areas. If such damage does exist, it would likely be a contributing actor to the generally undulating and springy feel of the first floor flooring and the sloping character of the second floor.

Photo 59. Detail Termite Damage at Floor Joist in Basement.

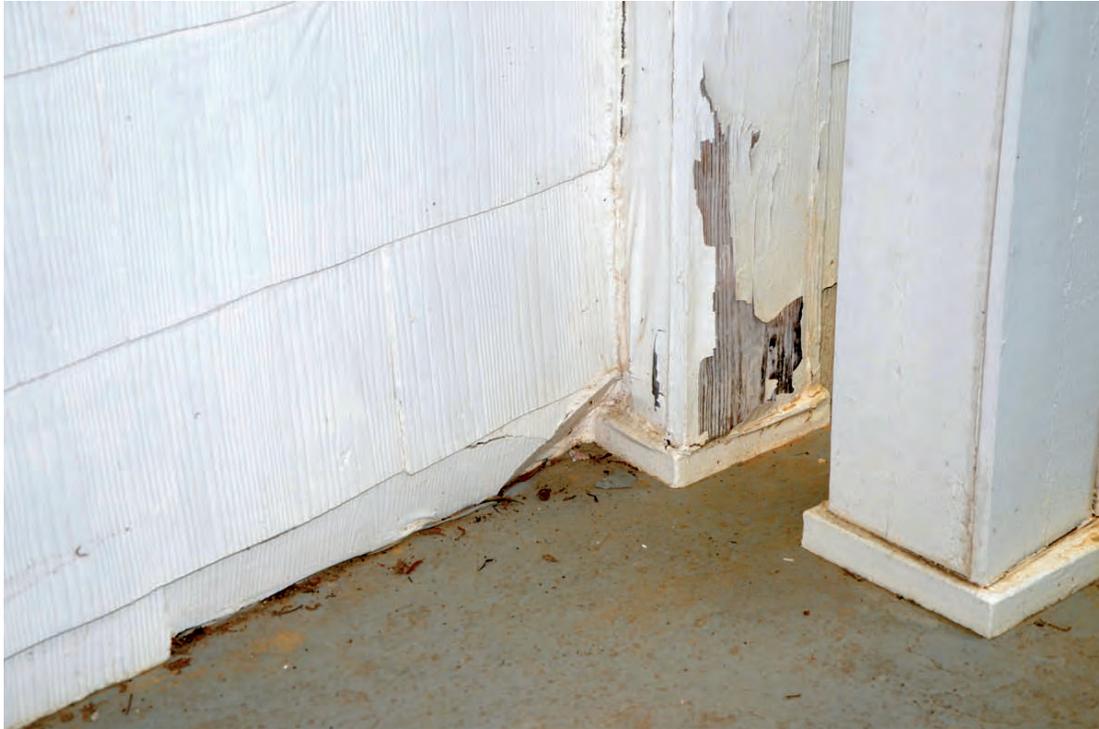
Photo 60. View at Front Porch. Note: Settlement of indicated by compression fracture of cement-fiber shingles at pilaster.

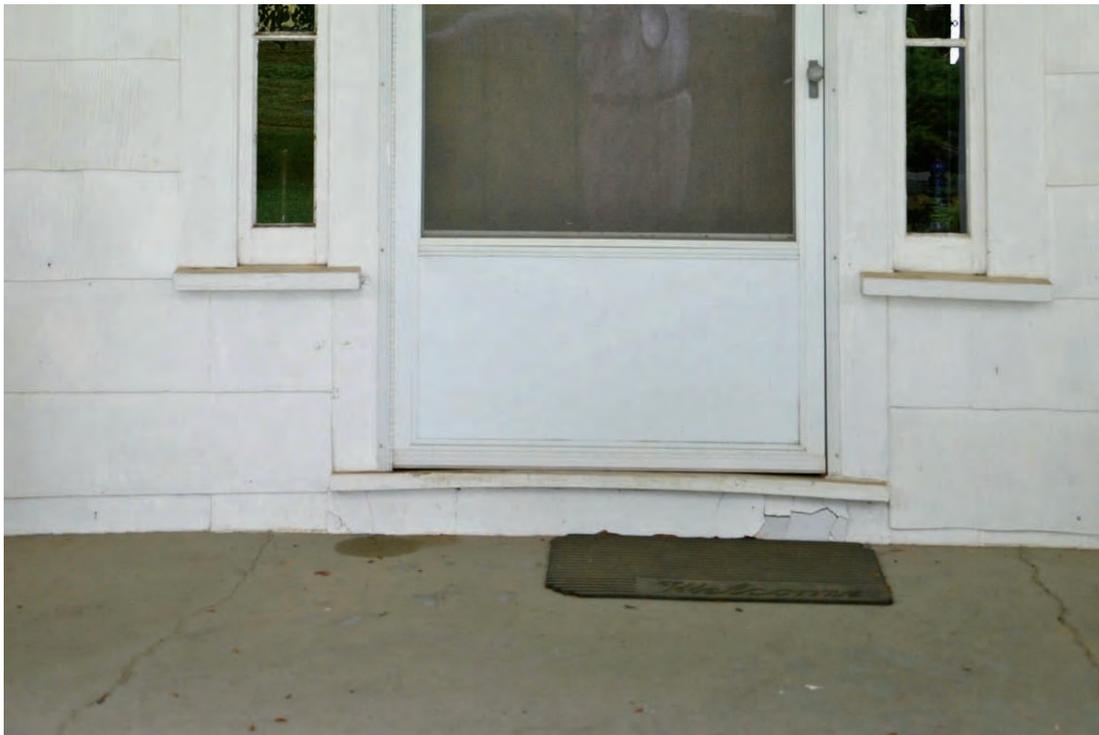
Photo 61. View at Front Entrance. Note: Settlement of door sill and compression fracture of cement-fiber shingles at right corner.

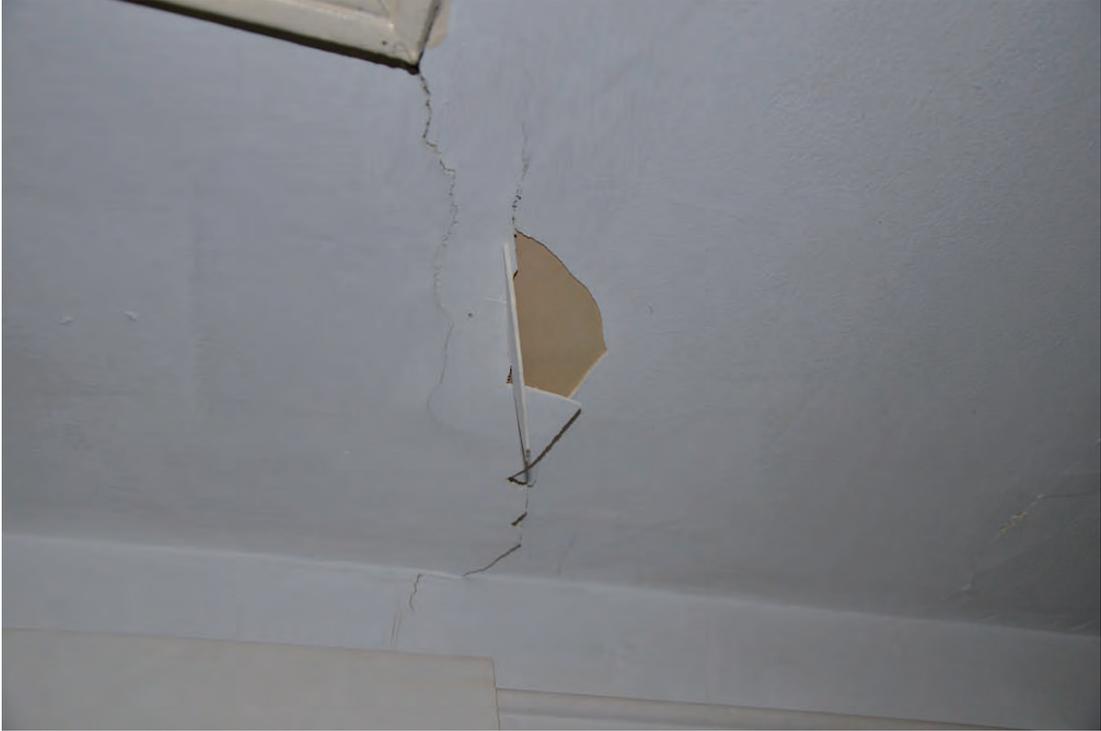
Photo 62. Detail of Settlement Crack

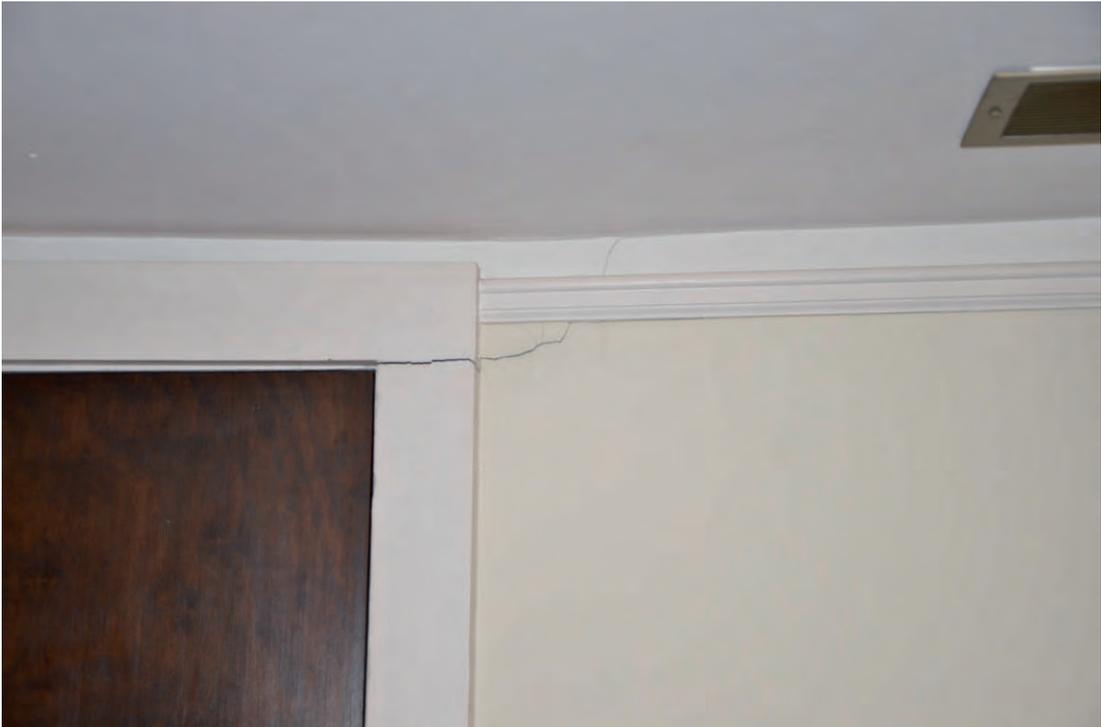
Photo 63. Detail of Settlement Crack, Room 204

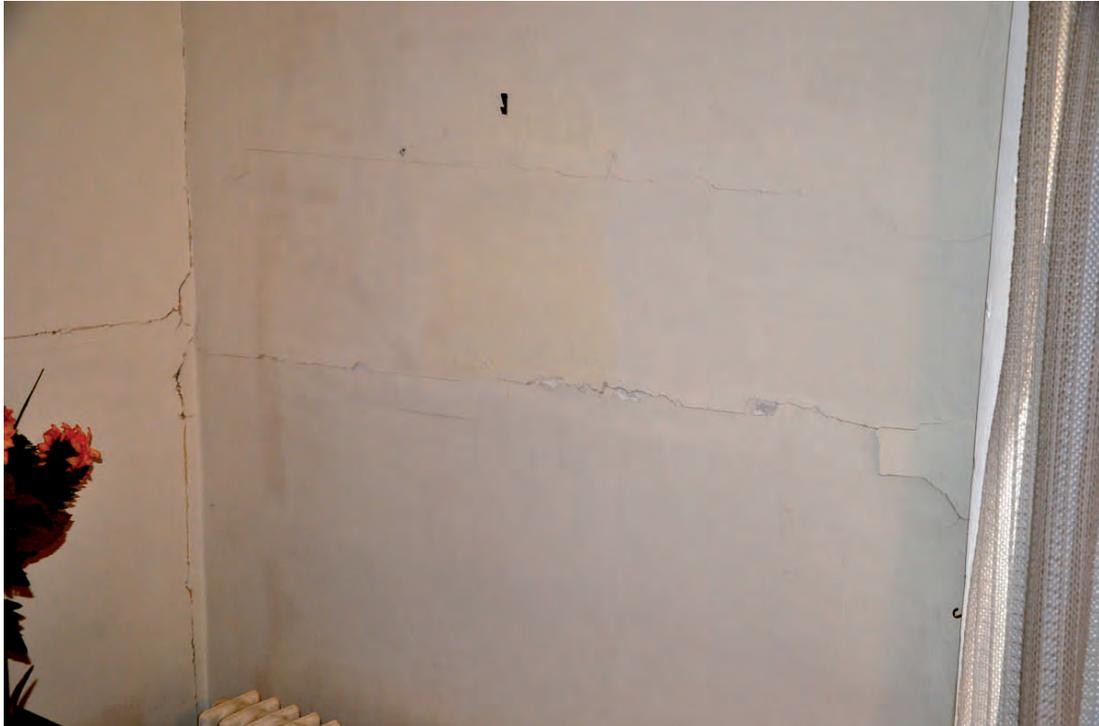
Photo 64. Detail of Settlement Cracks.

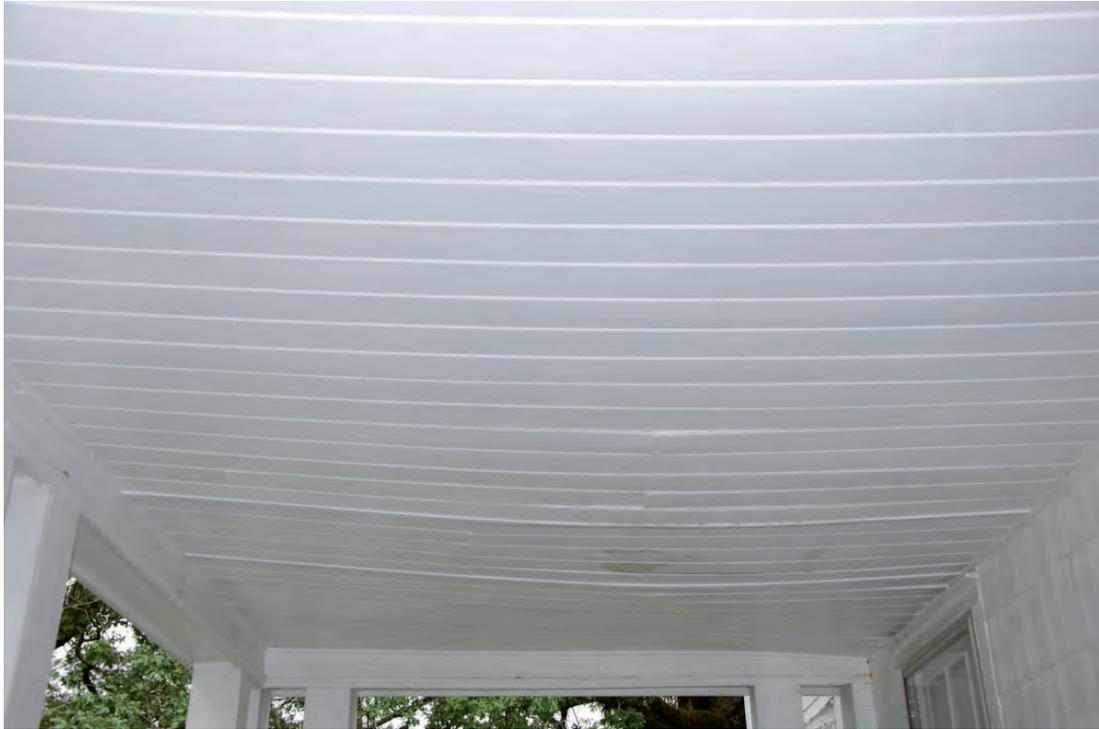
The metal roofing that was added in recent years above the front porch does not appear to have been adequately flashed at the house or perimeter. Paint failures at the ceiling of the porch and at the pilasters along the south elevation indicate moisture penetration through the ceiling and down the pilasters.

Photo 65. Detail of Porch Ceiling. Note moisture-related damage.

Recommendation. Some destructive exploratory work will be necessary to determine exactly how the new roofing was intended to be watertight along the front of the house. It is possible that there is some linkage between the floor joist failure at the foundation due to their corresponding location. Opening up some areas of the seam between the roofing and the house will both answer the question of the nature of this joint, but should also indicate if this joint had failed prior to the installation of the present roof. This evaluation and investigation should also be made by a structural engineer and may also require the use of a contractor or possibly a city work crew working with the guidance of the engineer.

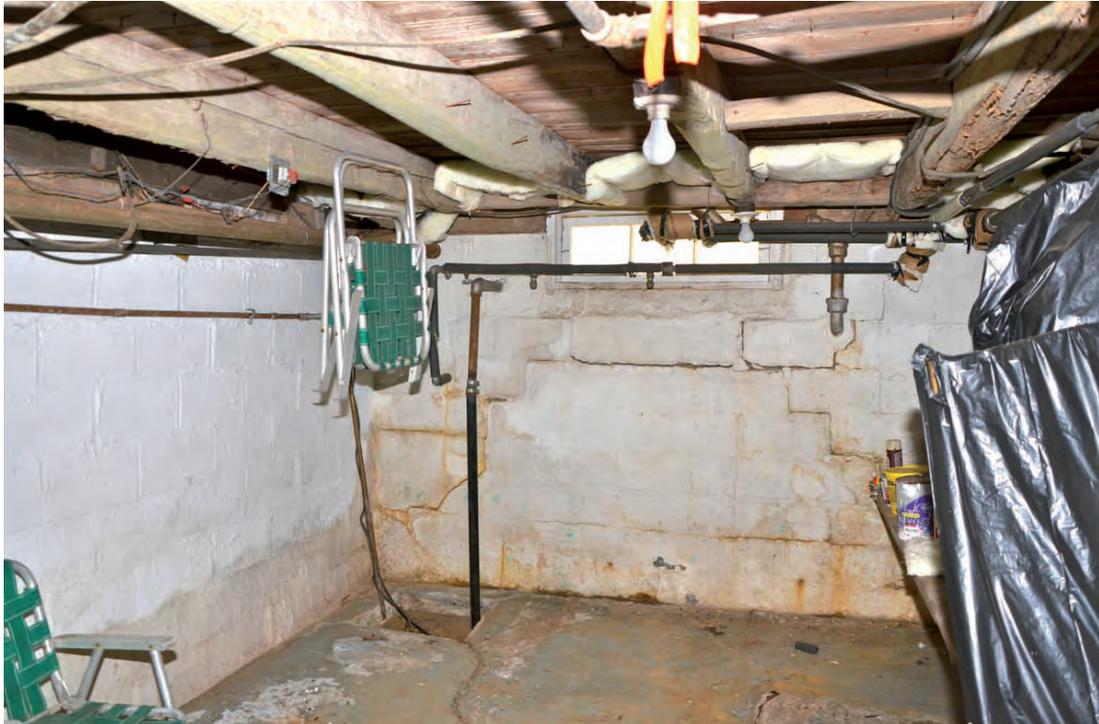
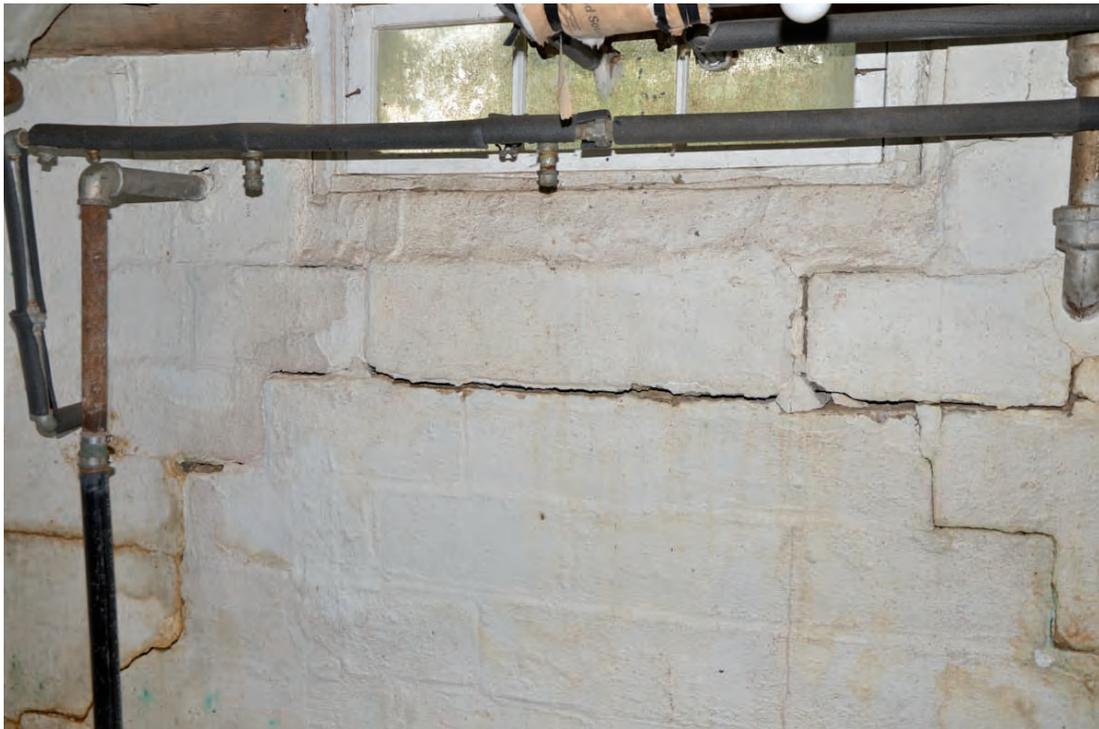
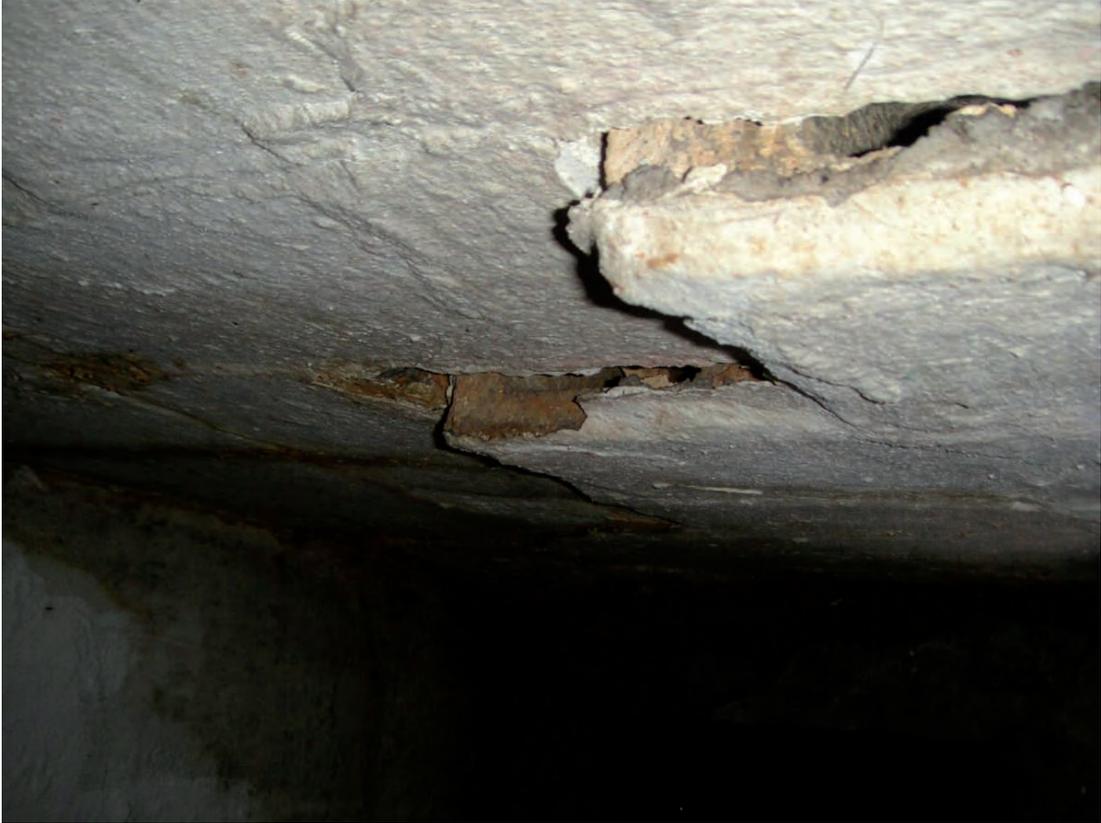
The west wall of the basement contains significant cracks and has moved inward below the window. This appears to be a long-term issue based on the undersized nature of the concrete masonry units used to construct the basement. The ground pressure outside the wall is gradually pushing it inward and it will likely eventually fail.

Photo 66. Detail of West Wall at Basement. Note: cracking and wall being pushed out below window.

Photo 67. Detail of West Wall at Basement. Note: cracking and wall being pushed out below window.

Photo 68. Detail of West Wall at Basement. Note: cracking and wall being pushed out below window.

Recommendation. The structural engineer should further evaluate this condition and prepare drawings and/or specifications for correcting the deficiency.

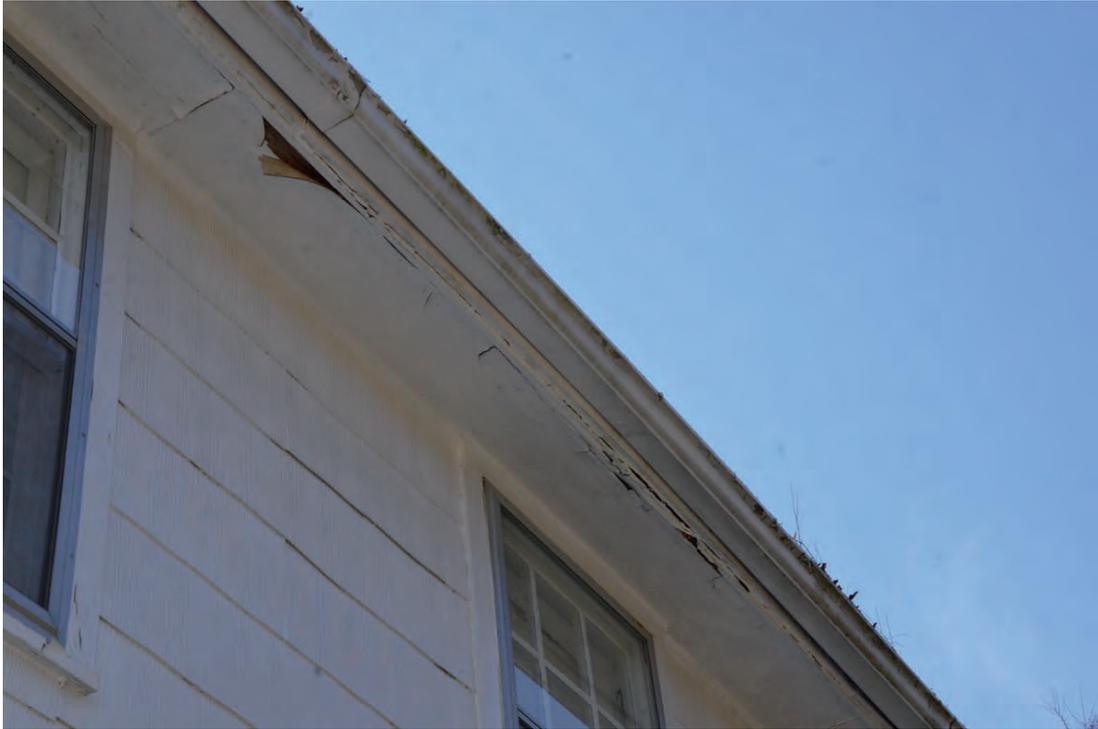
Gutters. It appears that gutters have become clogged resulting in water overflowing and causing paint failure on the cornice and wall surfaces below. The gutters should be cleaned immediately and inspected and/or cleaned periodically to prevent this condition. Downspout drainage should be directed away from the house particularly near the basement so that lateral earth pressures aren't increased in the area of the failing wall.

Photo 69. Detail of North Gutter. Note: Paint failure caused by clogged gutters.

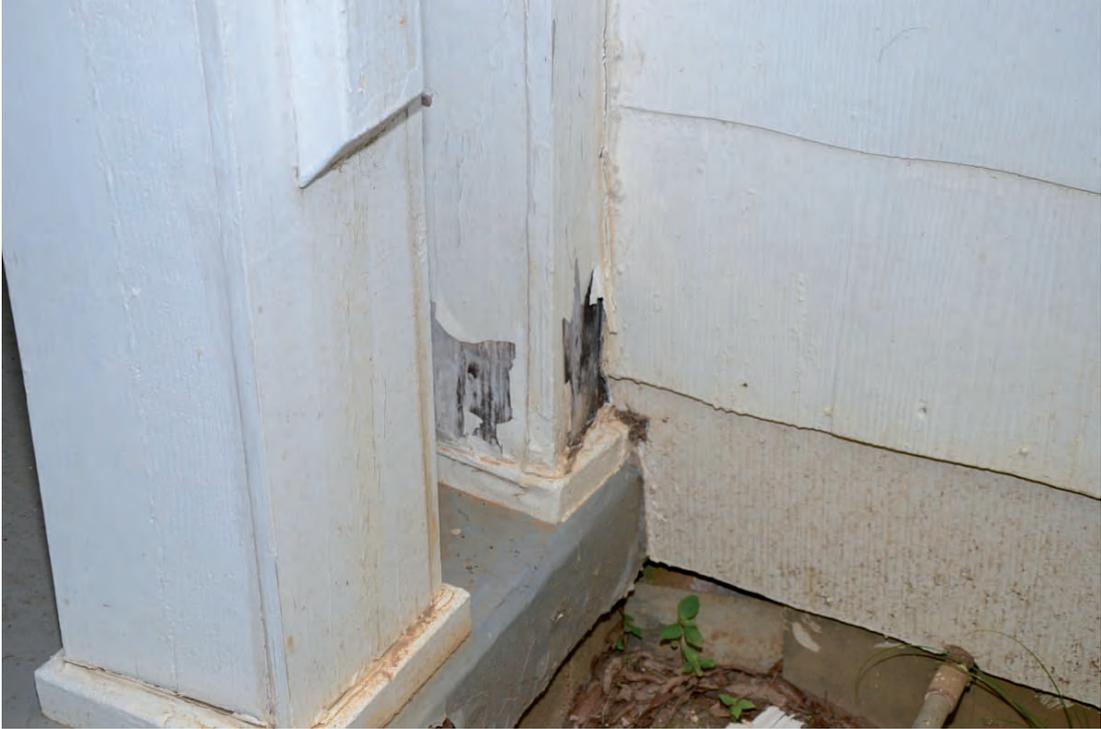
Photo 70. Detail of Pillaster. Note: Paint failure caused splash back and roof flashing leakage.

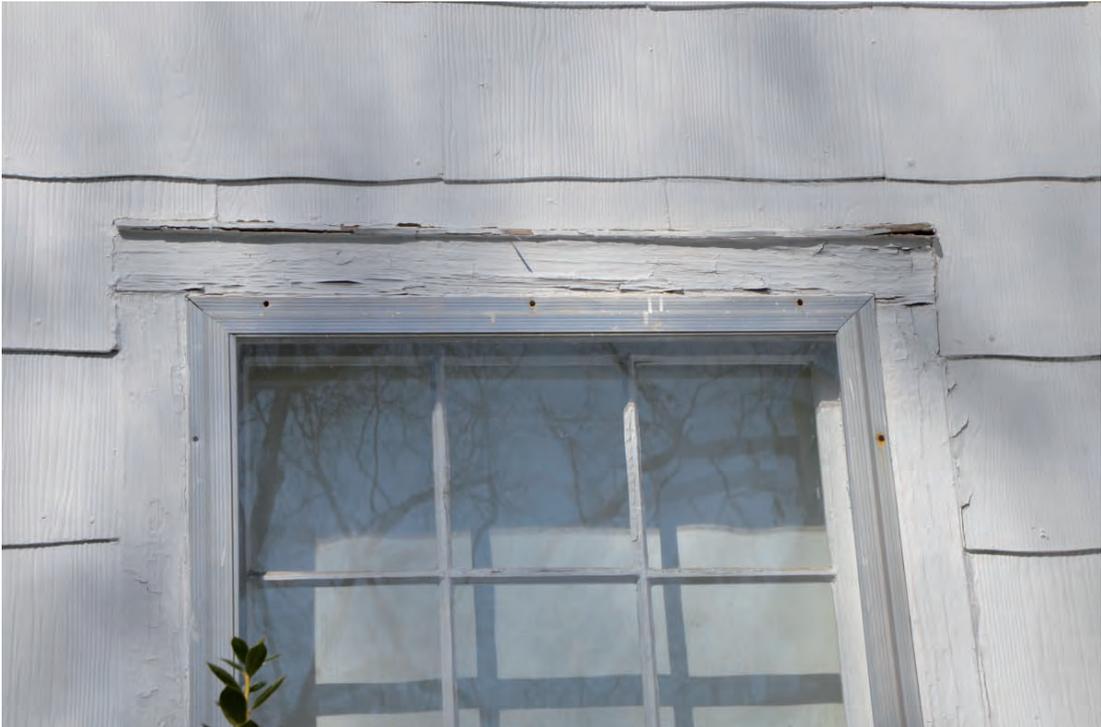
Photo 71. Detail of Window. Note: Paint and caulking failure at lintel.

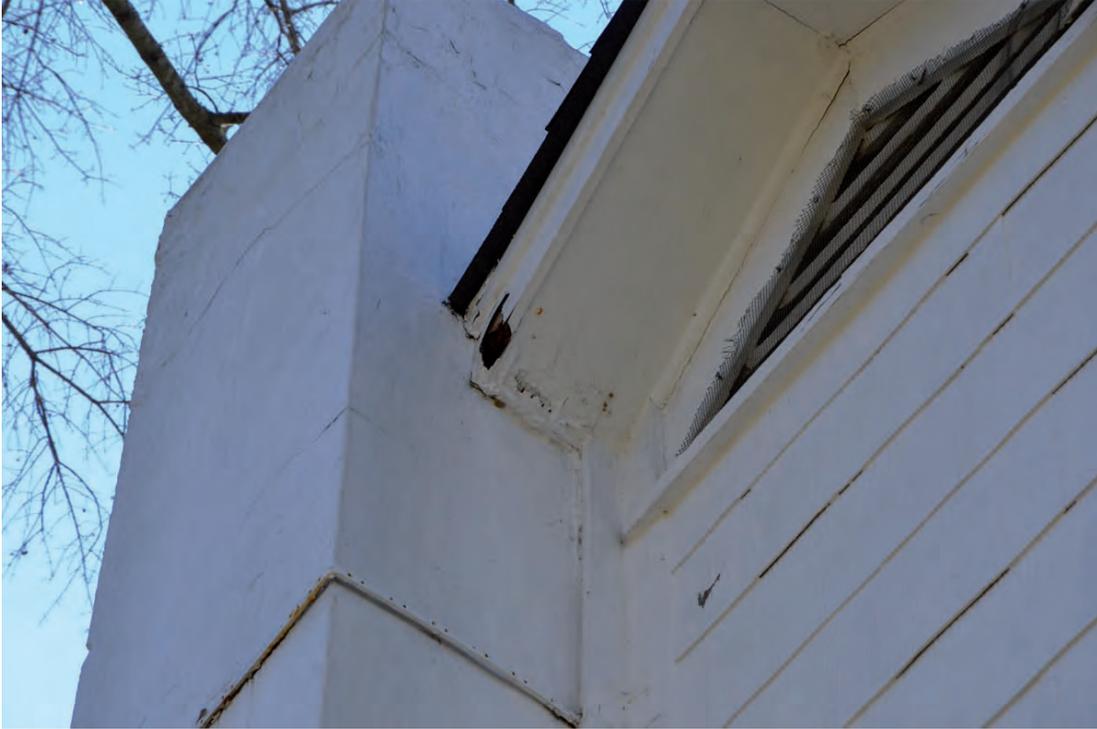
Photo 72. Detail of Eave. Note: Paint and caulking failure caused at chimney.

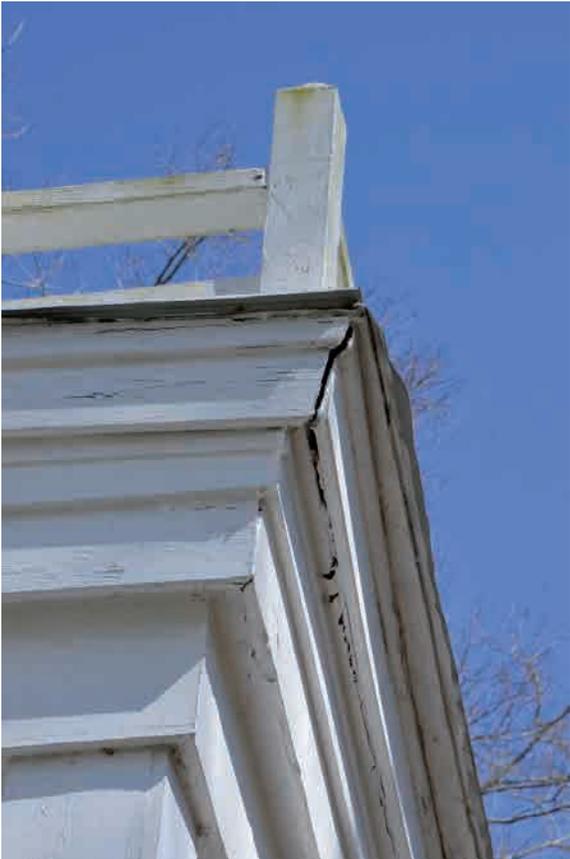
Photo 73. Detail of Porch. Note: Paint and caulking failure at corner.

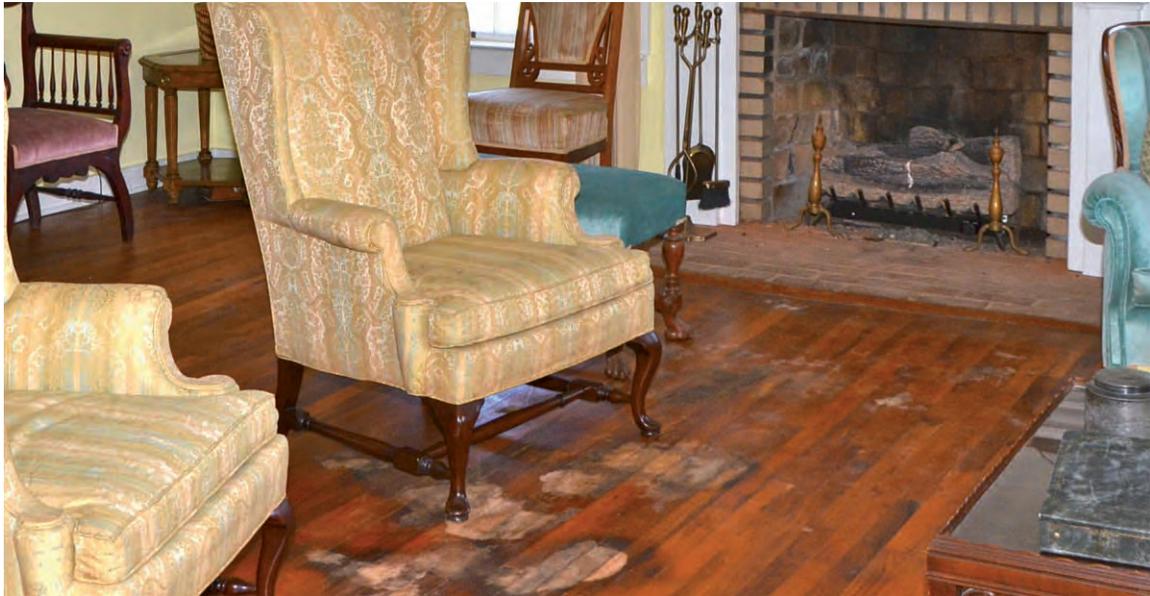
First Floor Flooring. The first floor flooring was installed during the 1946-1951 renovation. In recent years it has been severely damaged by pet staining. The staining is extensive enough that it likely has soaked into the wood and the seams in the flooring and it may be impossible to remove without substantial replacement of the wood itself. An experienced wood flooring expert should be consulted to determine if the staining can be removed simply by refinishing the surfaces or whether or not wood replacement will be necessary. If wood replacement is necessary, it should match the existing and adjacent historic conditions in design, materials, and workmanship.

Photo 74. Detail of Flooring at Parlor (Room 103), Detail of Pet Staining.

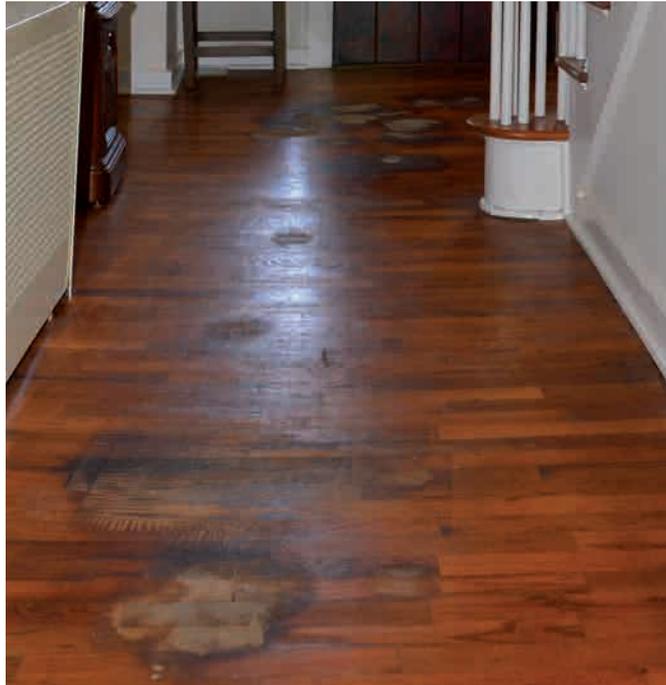
Photo 75. Detail of Flooring at Stair Hall (Room 101), Detail of Pet Staining
