Parnell Memorial Library

6/29/2021

277 Park Drive
Montevallo, AL 35115

ASSESSMENT REPORT

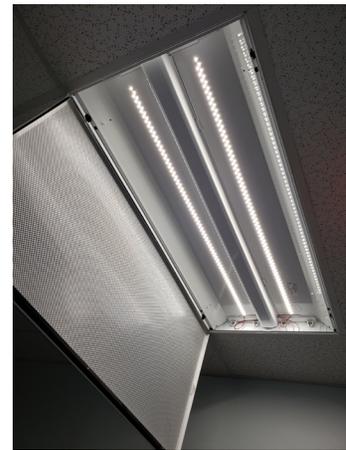
1. LED lighting Retrofit

The existing light fixtures have already been converted to LED. Savings were estimated using pre- and post- retrofit wattages and typical hours of use. Additional detail can be seen in Appendix A.

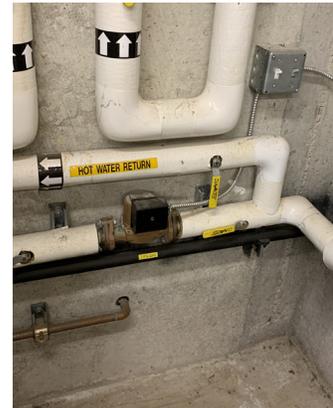
3. Timer for Hot Water Recirculating Pump

During the assessment, we observed one hot water recirculating pump on the main hot water line. Hot water recirculating pumps circulate hot water from the water heater throughout the building so that there is minimal waiting time for hot water when using a faucet that is not close to the water heater. The one we observed (pictured to the right) does not have a timer on it and likely runs 24/7. Adding a timer control to this unit so that it only operates when the building is occupied will save both pump electricity and water heater gas.

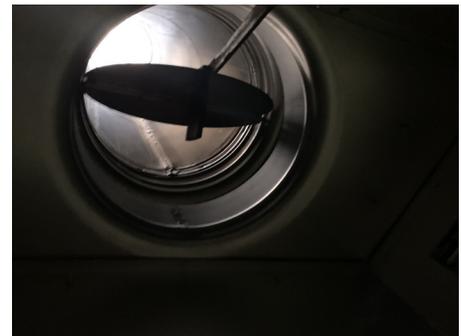
8. Maintenance: Closed Fireplace Flue While On Site

The fireplace flue was discovered to be open while on site, so Bryant closed it. This will help save a little bit of cooling and heating energy.

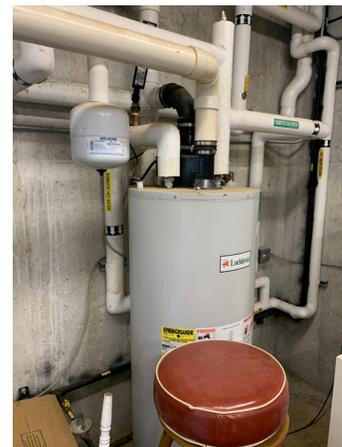
9. Maintenance: Repair or Replace Water Heater

The water heater was discovered to be attempting to fire, but failing to ignite. Also, the thermometer read about 80 degrees, when it should be 120 degrees or higher. It is recommended to have the unit fixed or replaced.

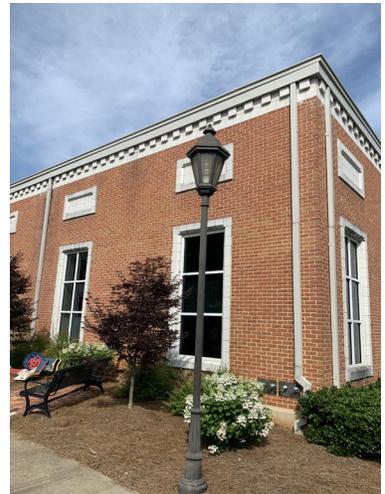
Lighting is almost entirely LED now that project #1 is complete. Retrofitting the pole top lights (photo at right) and the parking lot lights with LED is recommended as well. Payback of the individual fixtures can be seen in Appendix A.

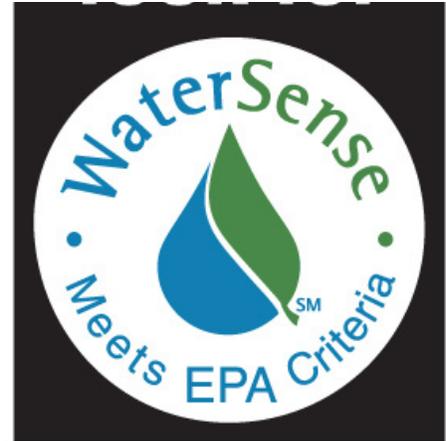
All current faucets, toilets, and urinals are standard efficiency fixtures. Retrofitting the existing with low-flow fixtures can reduce water usage by up to 46%.

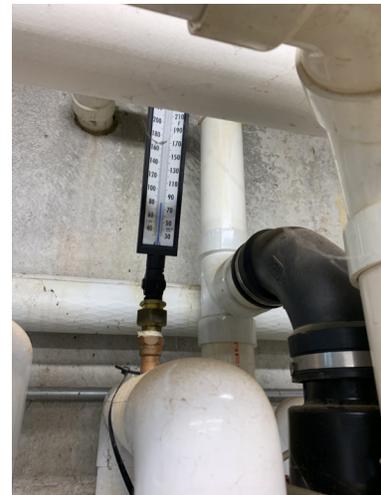
The current water heater is a 48 gallon top of the line Lochinvar condensing gas unit from 2005. The expected useful life of electric water heaters is around 13 years, so it could be replaced at any time, however if it hasn't been operating for a while so it may still have some life in it if it gets repaired.

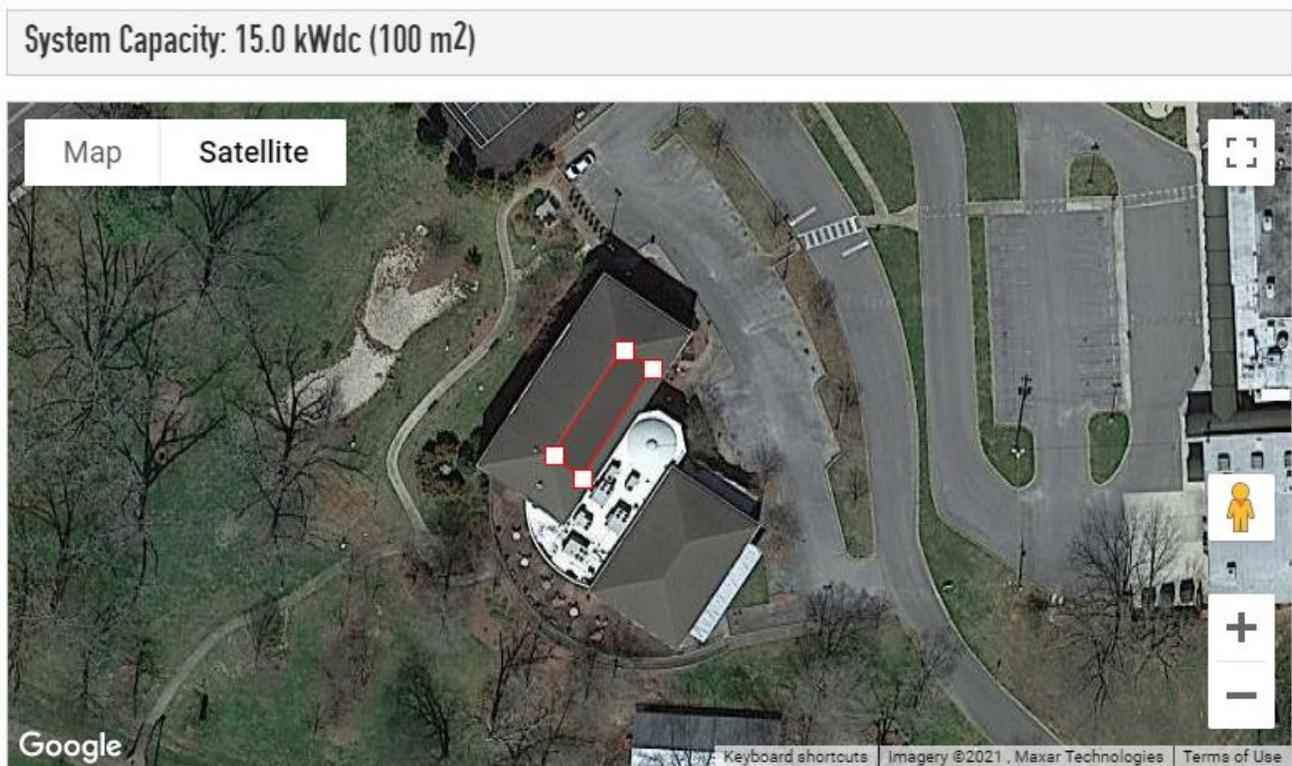
Appendix C: Solar Panel Detail

The PV system sizing and production was estimated using PV Watts. The estimated monthly energy production and footprint can be seen below.
