# Perry Hall (The Mahler Farm) Historic Structures Report

Draft, June 15, 2015

David B. Schneider  
Schneider Historic Preservation, LLC

Lowell Christy  
Christy/Cobb Consulting Engineers, Inc.

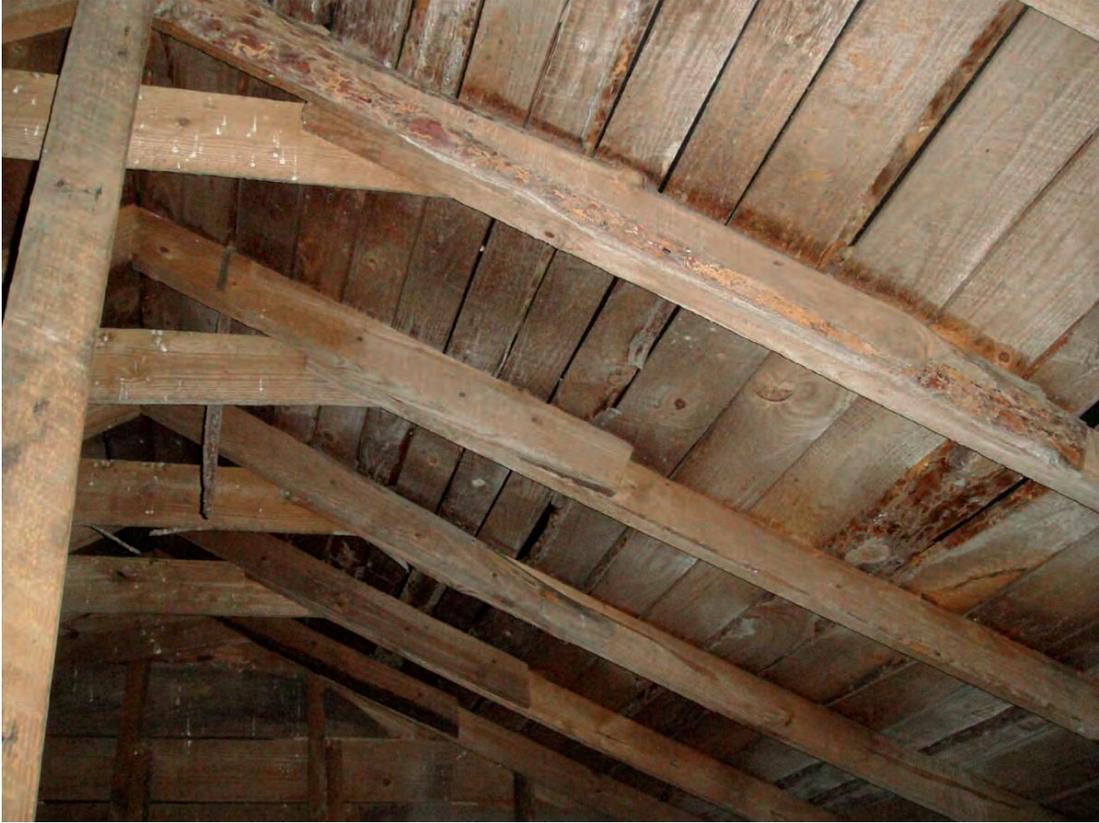
Photo 37. Interior, Attic, Camera Facing Southwest; Note Rafter extensions.

Rafter extensions for the higher roof appear to be functioning adequately and provide a clear load path though the lap splices are likely to be inadequate by today's standards.

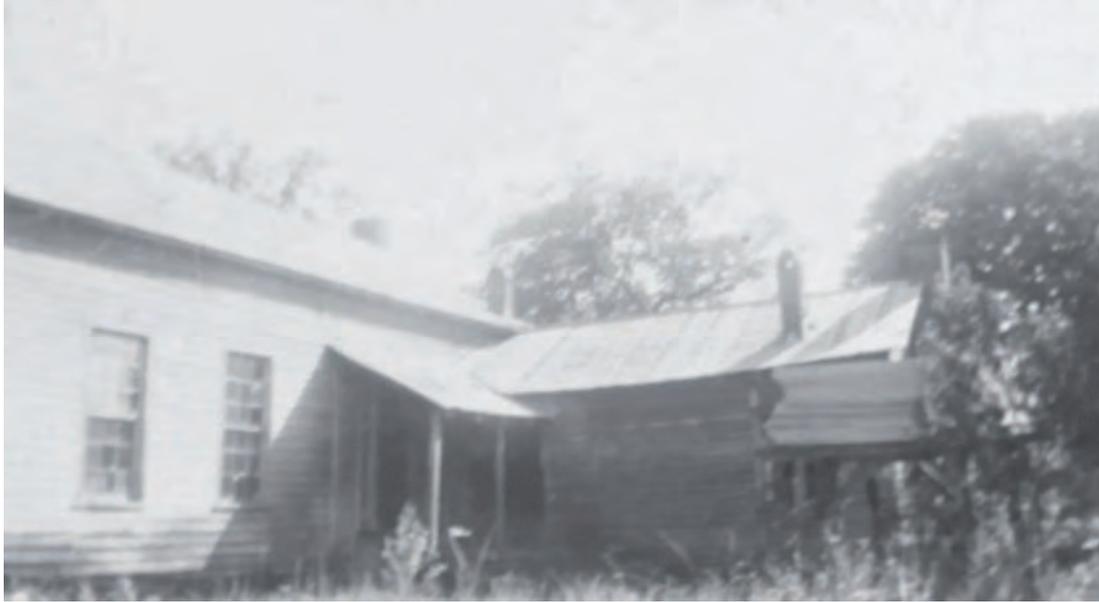
Historic View #4. Rear of Farmhouse, 1946. Note: The original rear roofline of the house (to the left) and the kitchen at right..

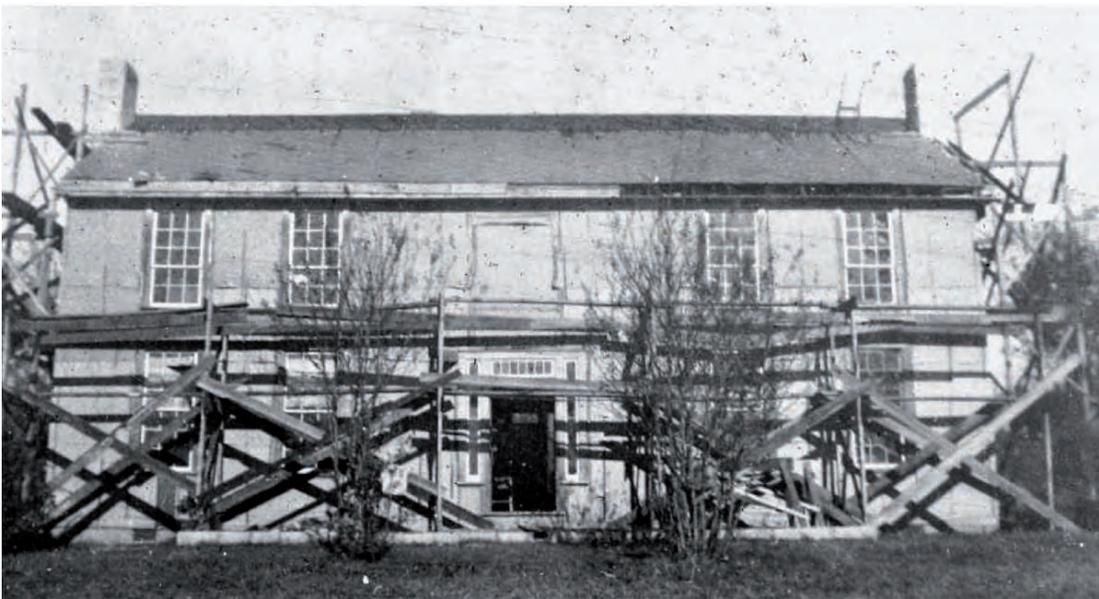
Historic View #7. Farmhouse ca. 1950. Note: Siding is being replaced, cornice is being rebuilt, and the entrance and window sash have been retained.

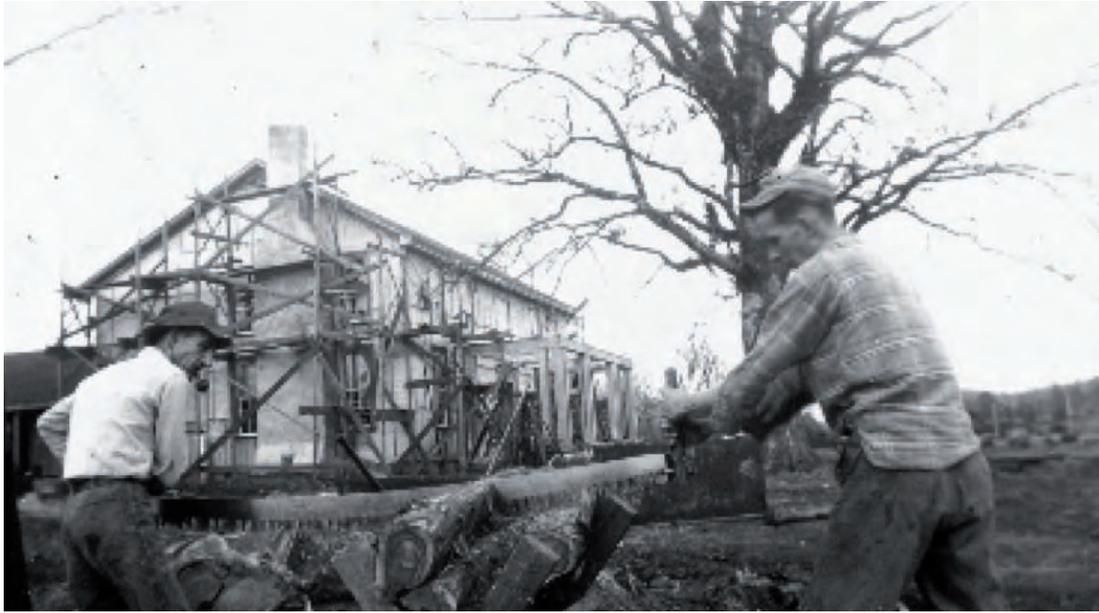
Historic View #8. Farmhouse ca. 1950. Note: Chimney and siding have been replaced, the roofline has been changed, and the porch is under construction.

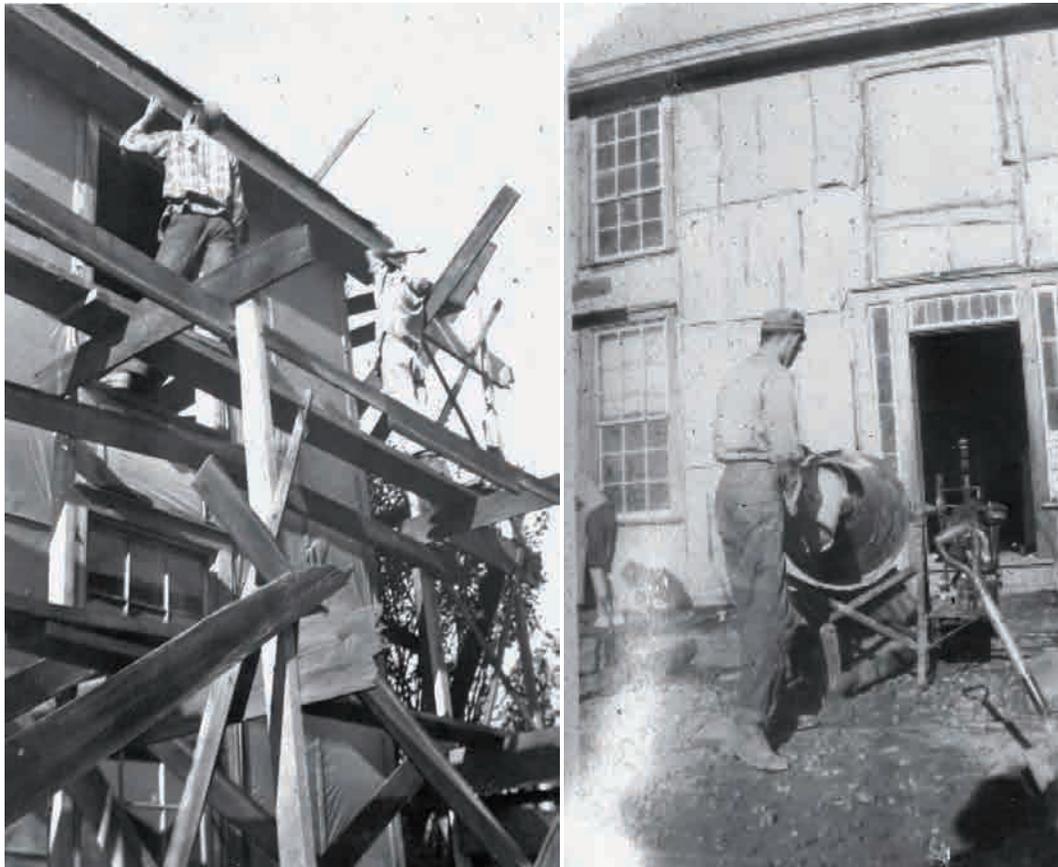
Historic Views #9-10. Farmhouse ca. 1950. Note: Cornice being rebuilt, siding being replaced, and entrance and window sash retained.

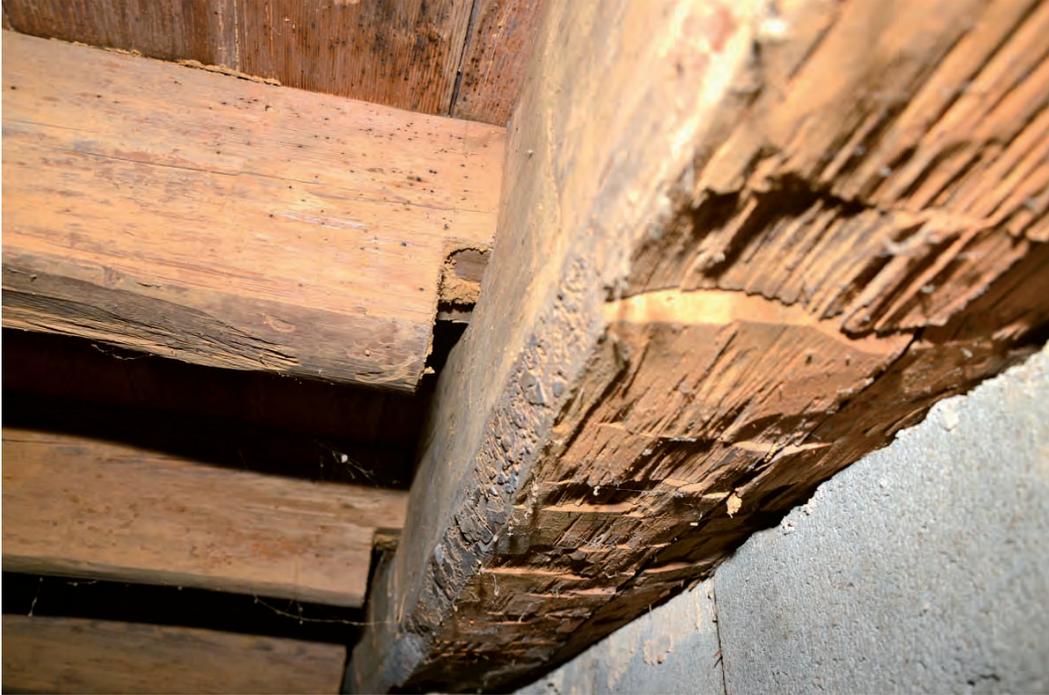
Access to the crawl space under the house is limited, as the floor joists and sills are typically less than 18" above grade. Without the aid of specialized viewing equipment or the opening of more access points along the foundation, it was only possible to observe a small area under the house and to obtain a few photographs. What was immediately visible along the sill at the front (south) façade of the house was that a number of floor joists that have separated in whole or part from the sill. This condition would certainly account for some of the settlement and deflection cracks that are found throughout the interior and the undulating and spongy nature of the first floor flooring. Due to the limited access, it was not possible to assess the conditions under the house beyond the one access point at the west end of the south wall. However, the presence of settlement and deflection cracks and the springy nature of the floor throughout the house indicates that similar conditions may exist along the western sill line and that there may be other issues with the floor joists themselves.

The crawlspace appeared to be relatively dry, so the underlying cause for the separation of the floor joists was not readily apparent. A contributing factor may be what appears to be the lack of a moisture barrier between the wooden sills and concrete masonry unit underpinning that was added during the 1946-1951 renovation. This condition should be further investigated as indicated below.

Photo 56. Detail View of Sill at South Facade. Note: hand-hewn sill now Resting directly on concrete masonry unit underpinning (1949/51)

Recommendation. The conditions at the foundation require more detailed examination that is beyond the scope of this project. Because the conditions within the crawlspace appear to be responsible for the ongoing settlement and deflection of the floor systems and the resulting cracking at ceiling and wall finishes, fully identifying the extent of deficiencies present, developing a plan to correct them, and making the necessary repairs is of primary

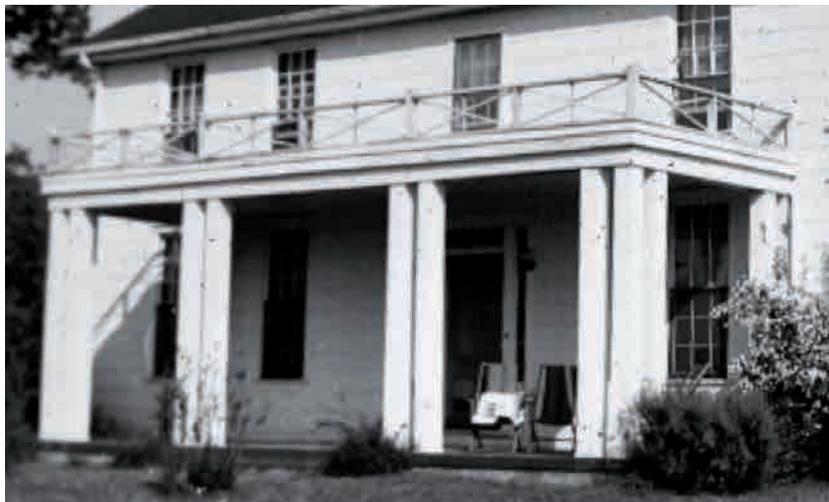
Photo 77. Detail of Roof Railing at Porch from 1951 Photo.

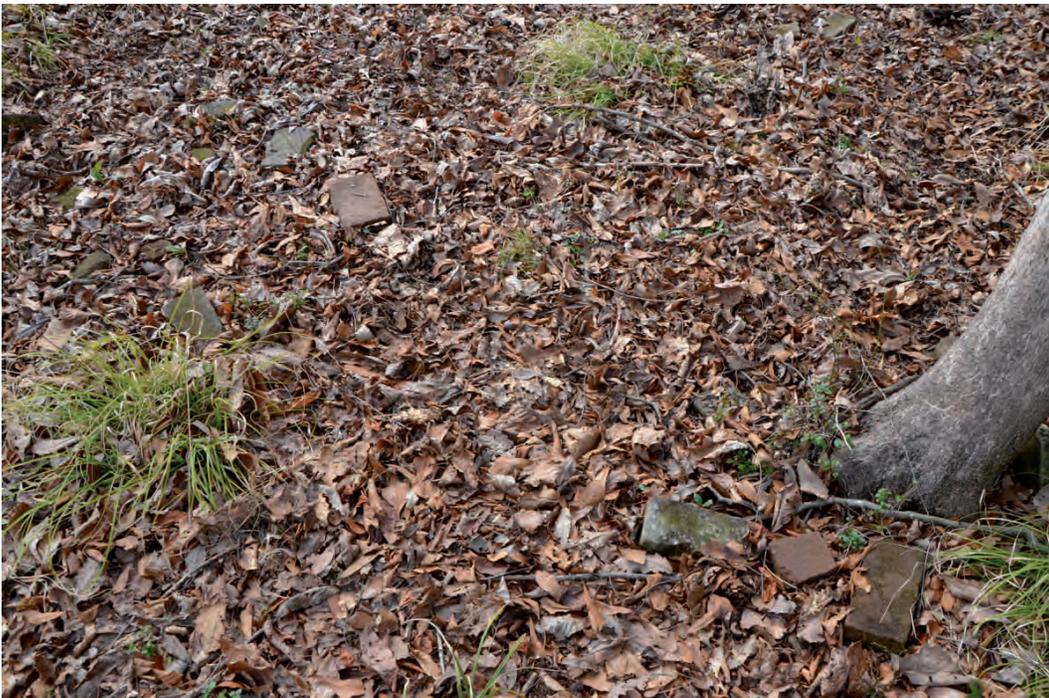
The small family cemetery at the northern property line is barely identifiable as a cemetery. Other than one intact marker for Elizabeth Teague Lawler, the remaining markers are broken or buried in whole or part.

Photo 79. Cemetery, General View.

Cemetery. The small family cemetery of the site should be evaluated by a specialist in historic cemetery preservation who should develop a plan for documenting existing conditions and conserving what remains.
